REF.: CH-BR-OL-RW-ZU-  
CFF Bridge La Presta – EN –  
ZP0450 – 10/03/2025

## CFF Bridge La Presta – Val-de-Travers, Switzerland

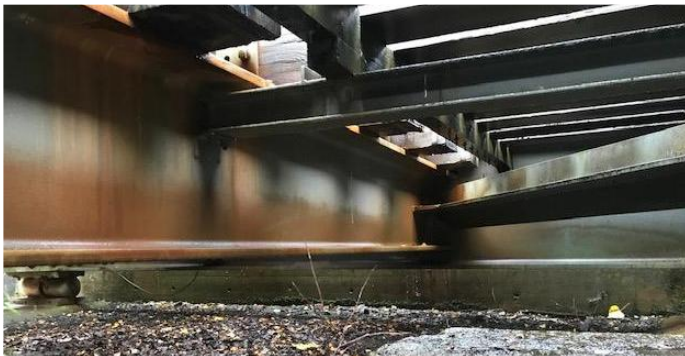
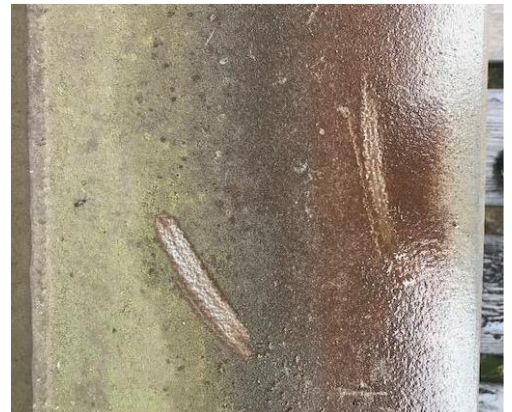
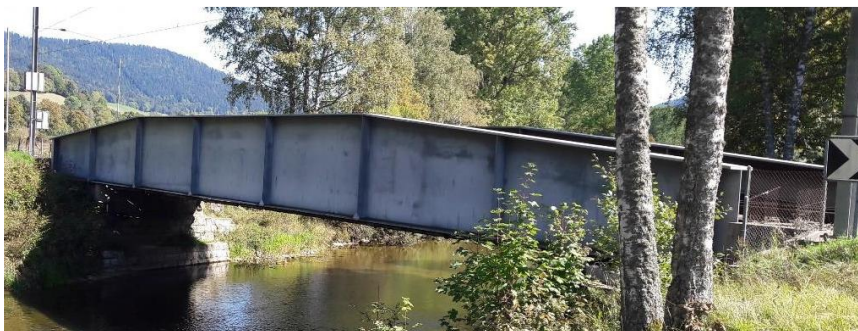
- Small pinpoint areas with surface corrosion (due to initial low DFT).
- Deposits of rusty iron filings / stains from the rails.
- Painting of the bridge structure is in good to very good condition.
- No areas of heavy rust or swelling were observed.

2 photos above:  
deposits of iron stains  
from the rails.  
When cleaning the  
superficial stains, you  
can see the active  
**ZINGA**.

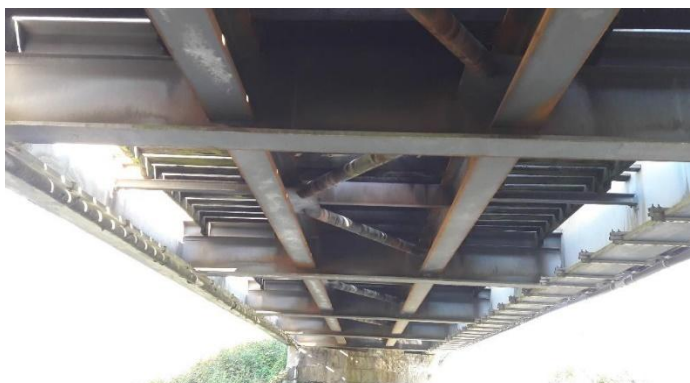
2 photos right:  
Overall structure of the  
bridge in good  
condition.

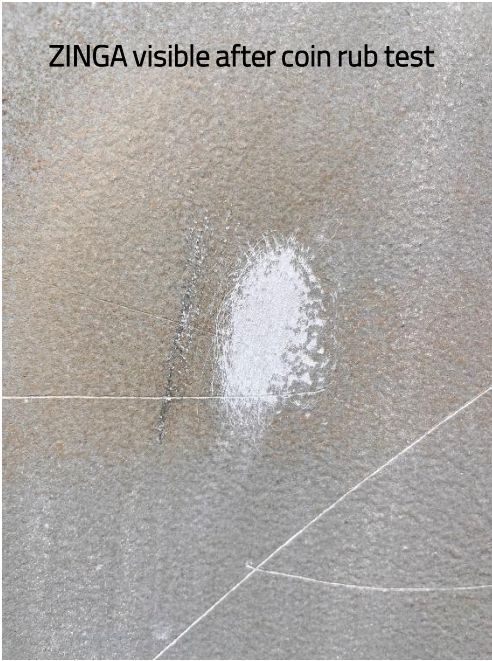
Coin rub and solvent rub tests were made which showed that the active ZINGA layer was intact.

ZINGA visible after coin rub test

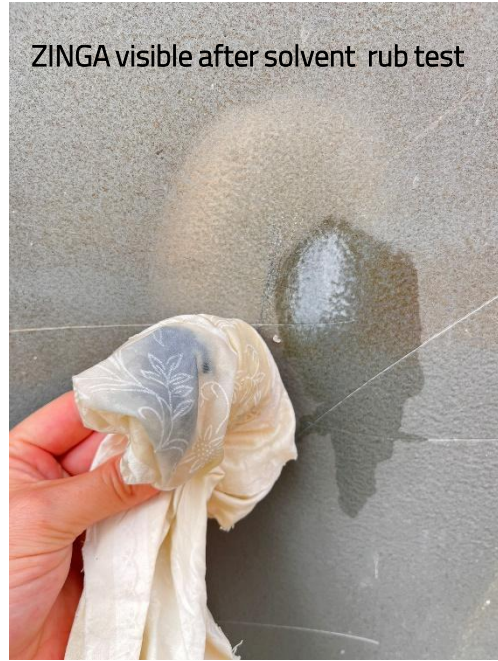
ZINGA visible after solvent rub test

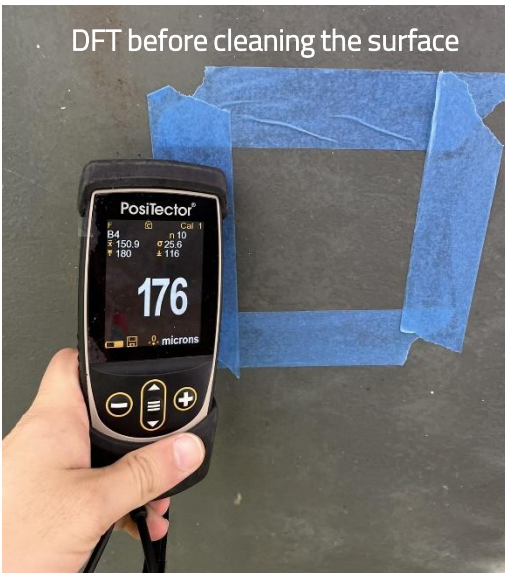
Thickness readings were taken, which were all between 110 to 200 µm DFT.

DFT before cleaning the surface

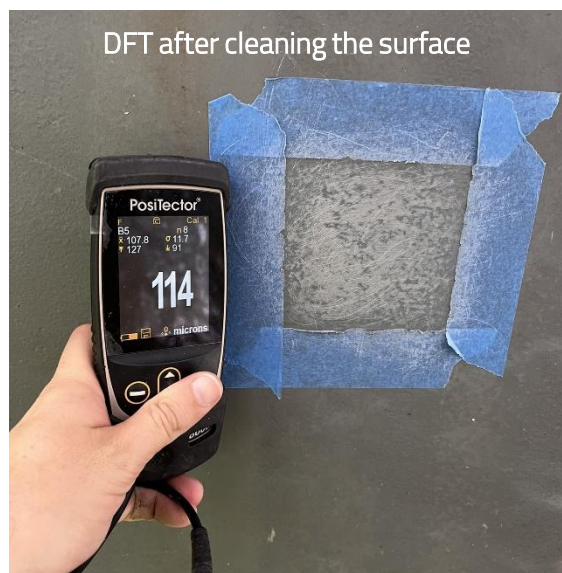
DFT after cleaning the surface

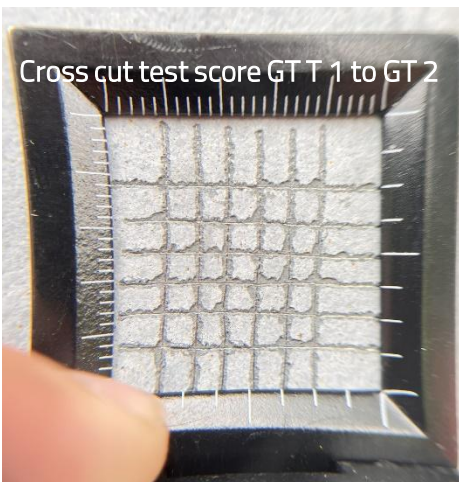
Cross cut adhesion tests were done (acc. ISO 2409) which gave GT1 to GT2 results.

Cross cut test score GT T 1 to GT 2
