REF.: CH-BR-OL-RW-ZU-  
CFF Bridge La Presta – EN –  
ZP0450 – 10/03/2025

## CFF Bridge La Presta – Val-de-Travers, Switzerland

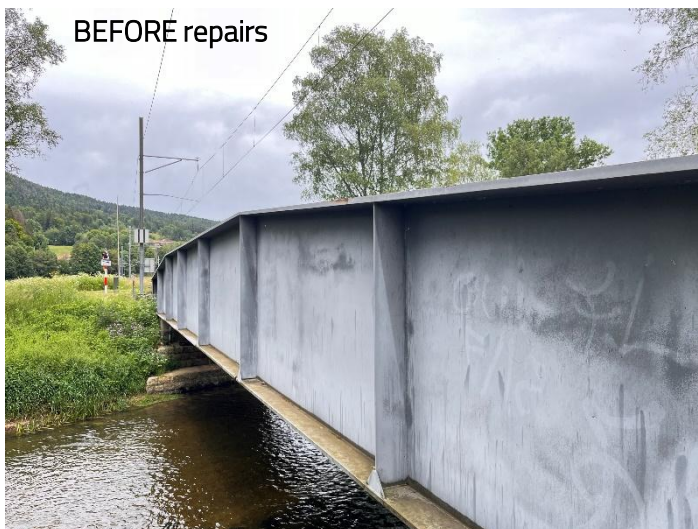
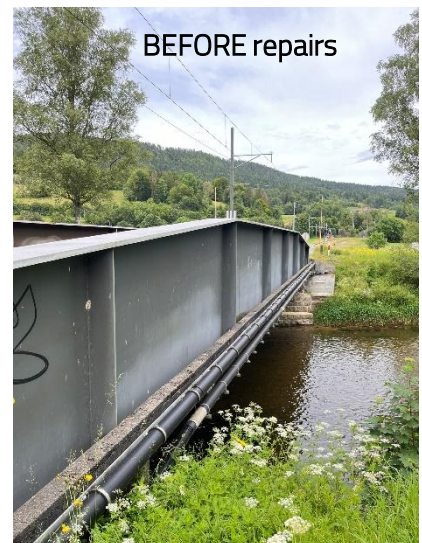
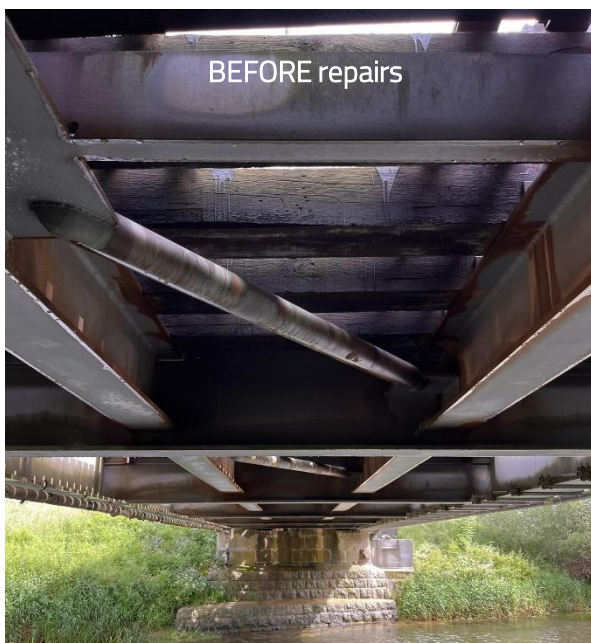
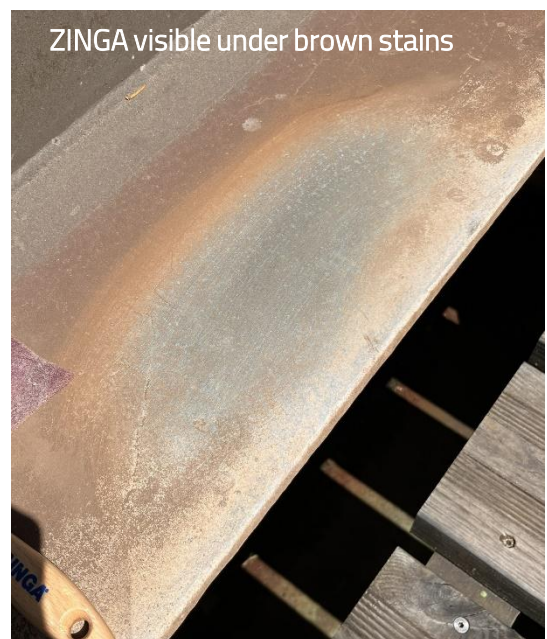
The overall condition of the bridge was satisfactory.

No defects as flaking, cracking, blistering or chalking were observed.

Near and under the train tracks red/brown deposits can be found which are particles and debris coming from the rails and overpassing trains. Underneath these deposits the ZINGA was intact.

Cross cut adhesion tests were done (acc. ISO 2409) which gave GT1 to GT2 results.

An easy ZINGA coating repair and reload/recharge specification has been issued and submitted to the Client CFF. The paint contractor SABLISOL started the repair works in **August 2024.**"

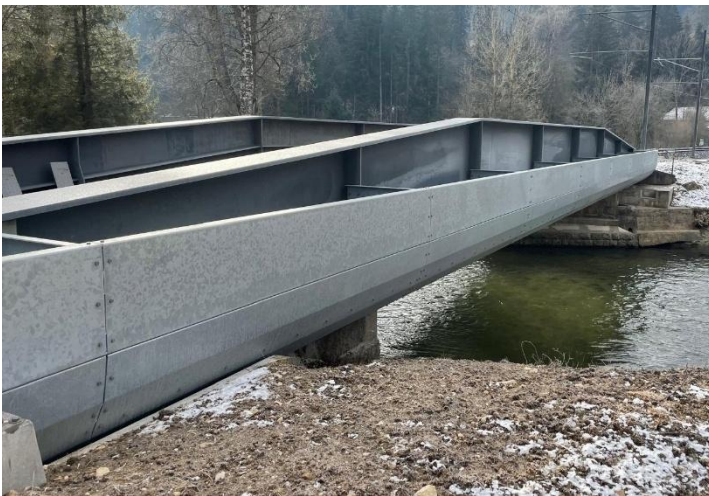
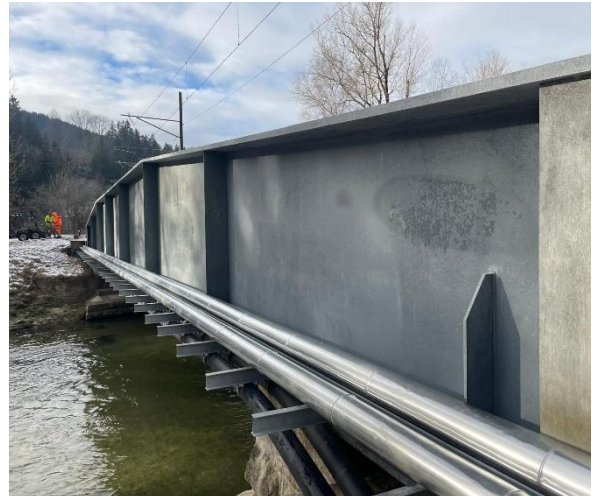
#### 2. Slightly rusted and Damaged Areas :

Areas showing rust, particularly around edges, welds, and under sleepers, are to be cleaned more thoroughly using power tools like the Bristle Blaster® and needle gun. The surface preparation is to be conducted to SSPC-SP 11 – Level 2 standards, ensuring a suitable substrate profile for coating adhesion of Rz 50 – 100 µm.

ZINGA was applied by brush and roller to 120µm DFT.
